IN THE  
**Supreme Court of the United States**

No. .... **78-1216**

**APPENDIX TO THE PETITION FOR A WRIT OF  
CERTIORARI TO THE UNITED STATES  
COURT OF APPEALS FOR THE NINTH CIRCUIT**

Appellant BOAC appeals from an order of the United States District Court for the Western District of Washington granting appellee The Boeing Company ("Boeing") summary judgment in a suit arising out of the crash of a Boeing 707 near Mt. Fuji, Japan, on March 5, 1966. BOAC, which owned and operated the plane, had sued Boeing for damages, alleging negligent design and manufacture,

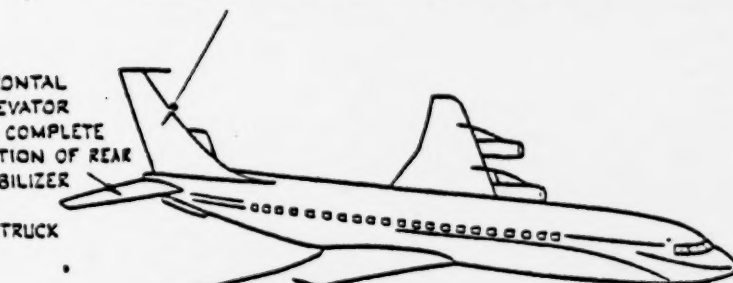
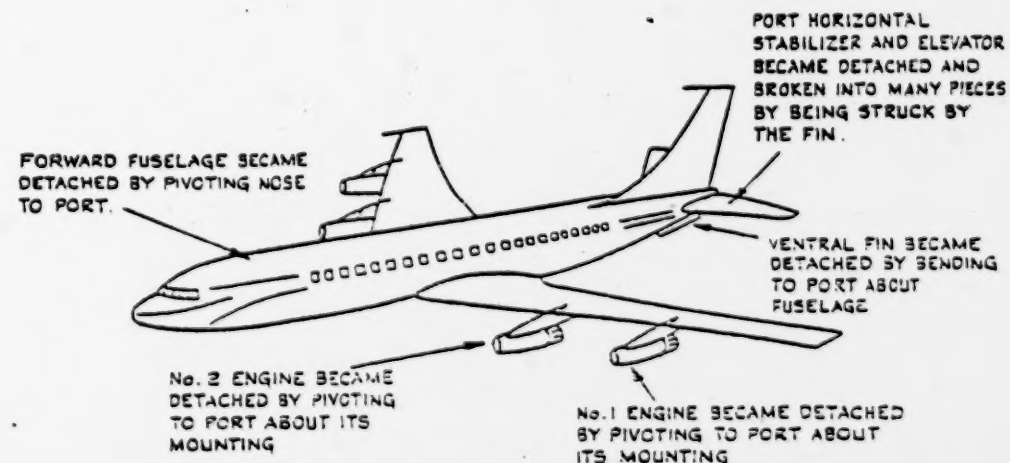
FIN AND RUDDER BECAME DETACHED BY BENDING TO PORT ABOUT FUSELAGE AND THEN ROTATING DOWNWARDS TO STRIKE PORT HORIZONTAL STABILIZER.

STARBOARD HORIZONTAL STABILIZER AND ELEVATOR BECAME DETACHED COMPLETE FOLLOWING DISRUPTION OF REAR FUSELAGE AND STABILIZER CENTRE-SECTION WHEN PORT SIDE STRUCK BY FIN.

STARBOARD MAINPLANE FAILED BY BENDING TIP UPWARDS, WITH NO EVIDENCE OF DRAG LOADS DURING SEPARATION FROM THE AIRCRAFT.

NO EVIDENCE OF MALFUNCTION WAS SEEN ON ANY COMPONENT EXAMINED

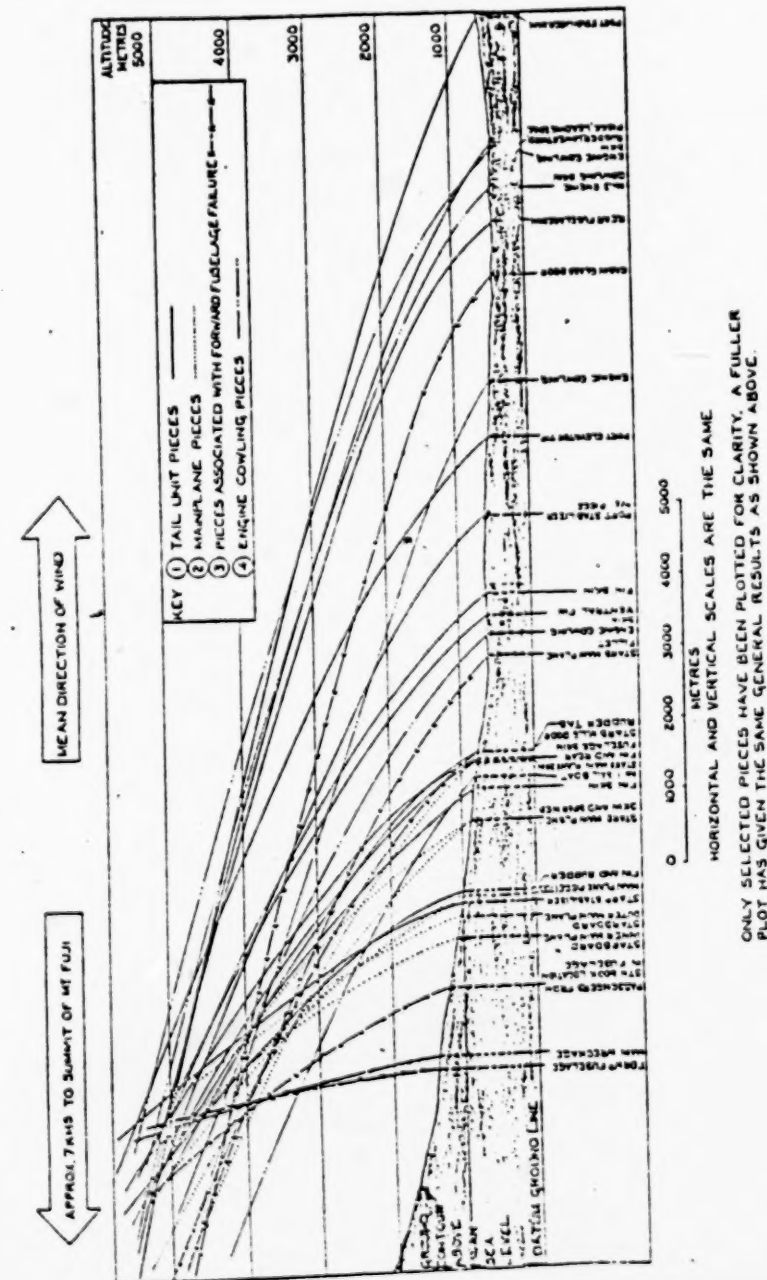
FIG. 11 WIND DRIFT TRAJECTORIES

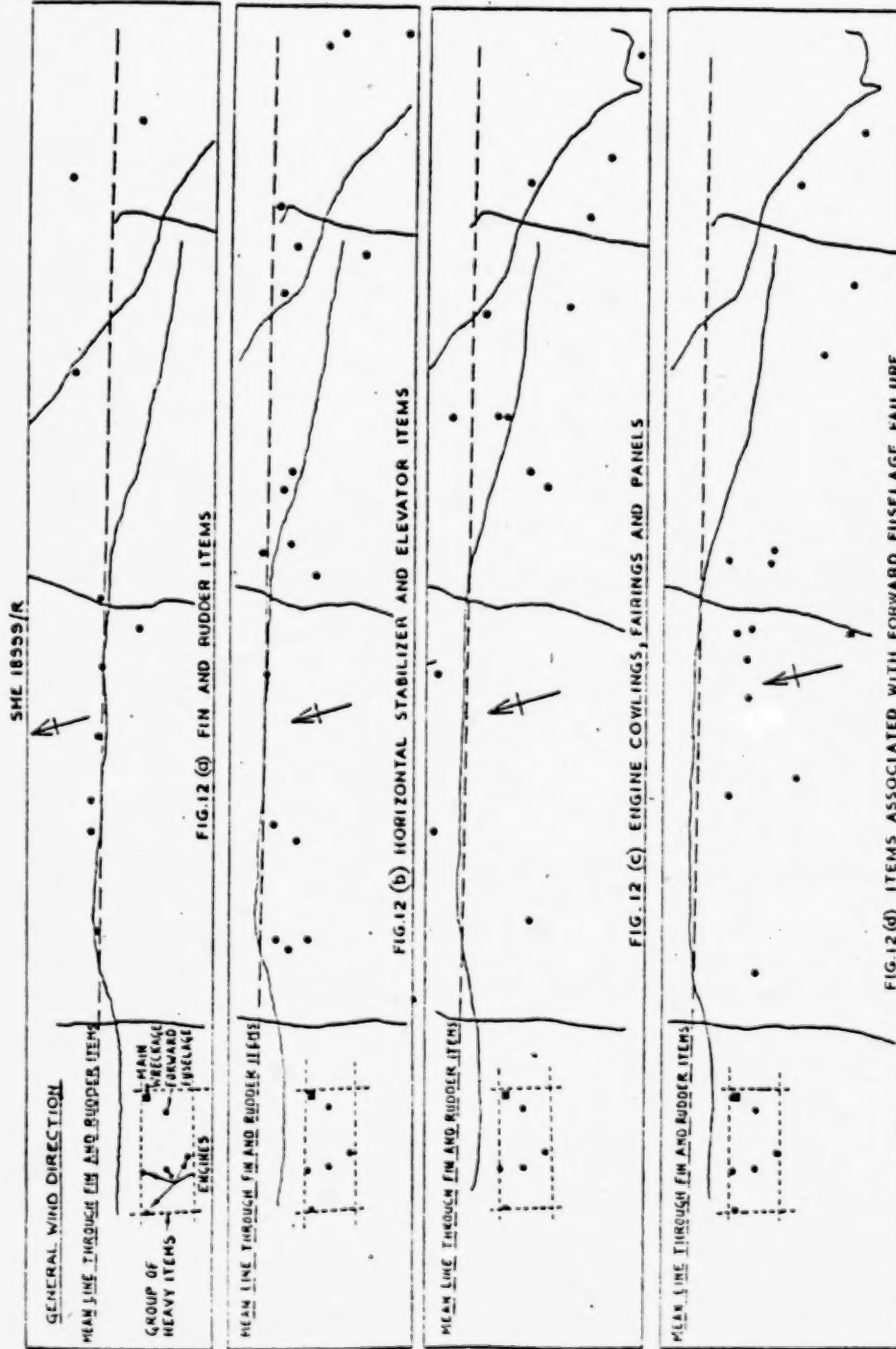
Fig 12

FIG. 12 ANALYSIS OF PLANFORM DISTRIBUTION OF WRECKAGE
